DAM SAFETY PROGRAM DAM INSPECTION REPORT FORM – FOR REGULATORY INSPECTION

Dam Name:	Knofla's Pond Dam	Inspection Date(s):	5/14/2015
Alternate Dam Name(s):		CT Dam ID #:	14203
Location (Municipality):	Tolland	Temperature / Weather:	70° Sunny
Registered?: Yes or No If yes, provide the 9 digit registration number found on the notification letter.	Yes 9/18/2002 (attached)	Pool Level: See Instructions	4" above drop Inlet crest elevation
Emergency Action Plan?: Yes or No If Yes, see instructions	No	Impoundment Use: use options listed in instructions	aesthetics/ conservation
Hydraulic and Hydrologic Analysis?: Yes or No If Yes, see instructions	Yes for original design	Stability Analysis?: Yes or No If Yes, see instructions	No
Overall Condition: (refer to Appendix A located at the end of this form) Satisfactory

General Description: Earthen Embankment Dam			
Hazard Classification: BB		Dam Height (ft): 9'±	
Dam Length (ft): 115'		Spillway Length (ft): 45'	
Spillway Type: drop inlet		Normal Freeboard (ft): 3 ½'	
Drainage Area (square miles): 0.58		Impoundment Area (at principal spillway crest, in acres): 5.65	
Watercourse(s): Cemetery Brook

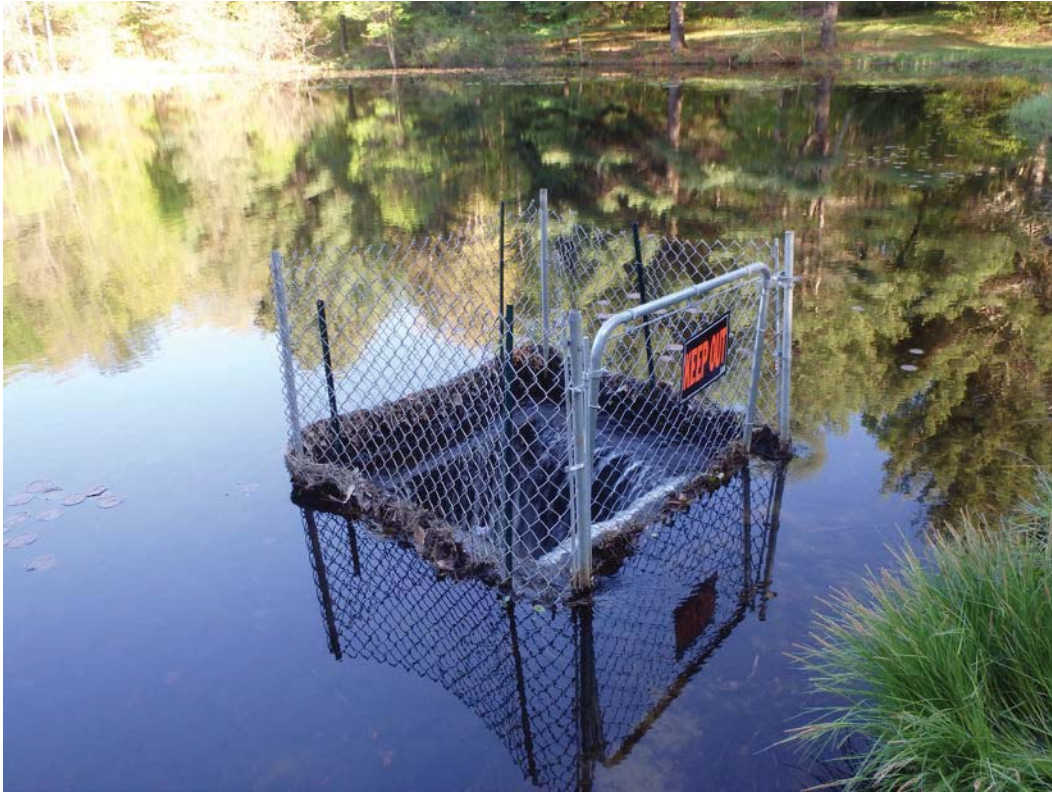
General Condition: Good condition. Minor spilling visible on interior of drop inlet.

Other: Chain link fence surrounding drop inlet as debris screen. In good condition since recently installed.

9. Overview of spillway(s) from upstream

1. Keep drop inlet clear of debris.
2. Remove debris in auxiliary channel at woody vegetation crowding channel outlet end.
3. Plan to remove all trees within 25 feet of dam components.
4. Explore restoring operability of low level outlet valve.
5. Longer term, plan to camera inspect the corrugated metal pipe in dry to assess degree of corrosion. It is to be expected that at some point future pipe will need to be repaired (proper slip lining) or replaced.

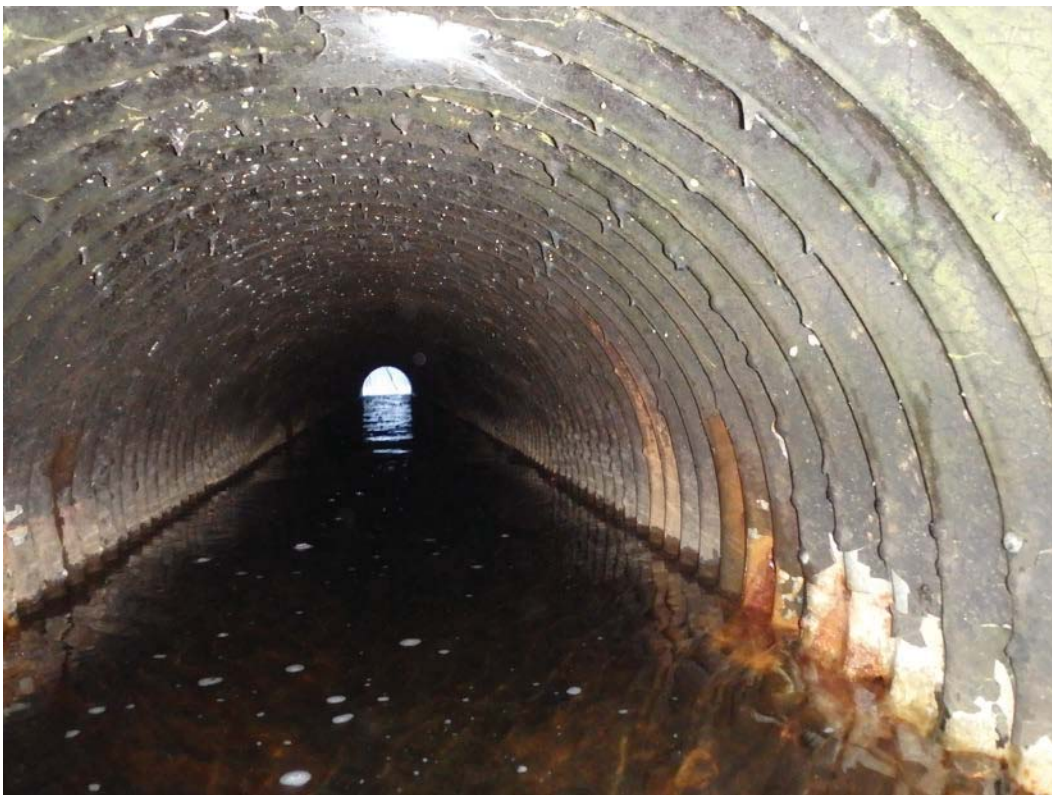
Stone Masonry: End wall is made of stone masonry and concrete block with concrete slurry and asphalt covering. Fair condition.

16. Outlet inlets and discharge points

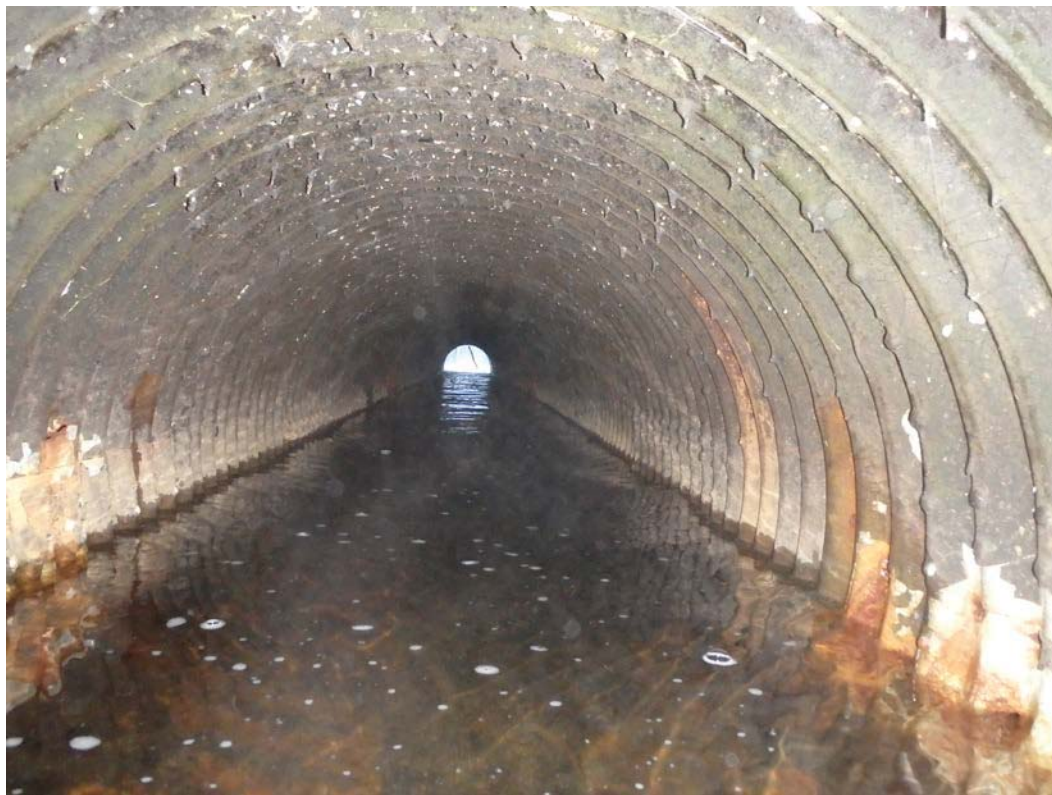
Scouring/Undermining: None observed; however, some soil loss to left of outlet pipe.

18. View of outlet conduit – note areas of corrosion

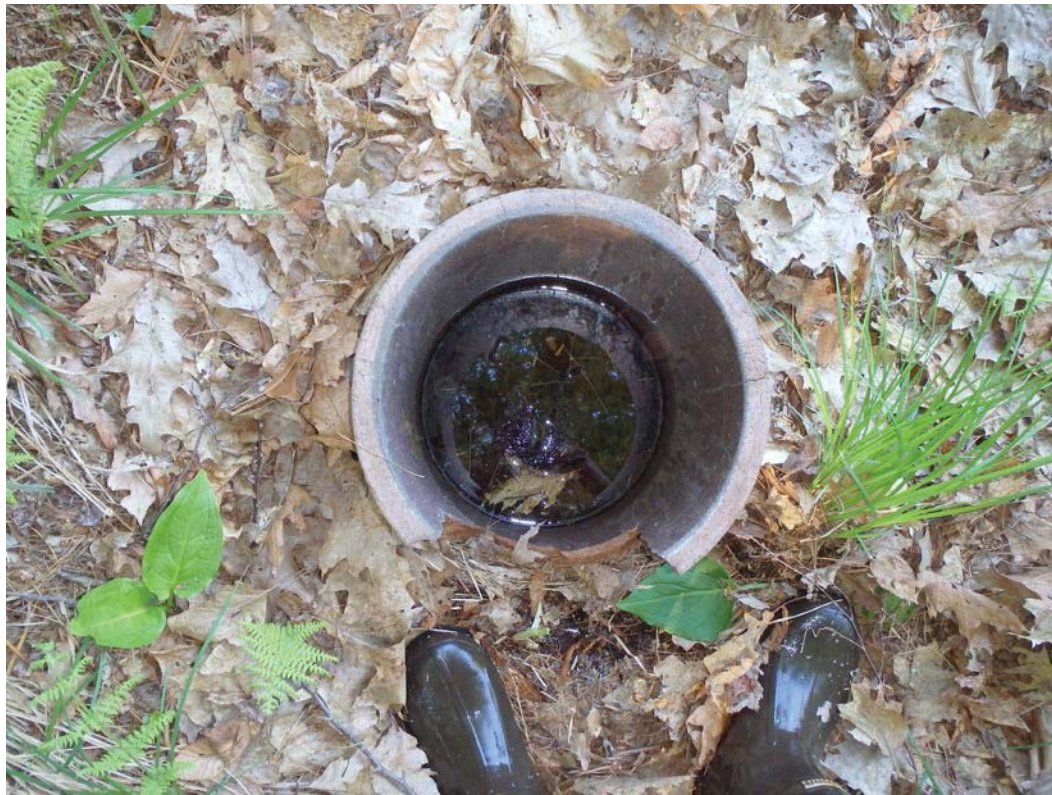
Seepage/Foundation Drainage: Seepage/Wet Area noted on d/s slope on left embankment and right embankment. Clay Well Tile 12" diameter on right d/s abutment contact. Water level approximately 6" below ground surface

19. View of vertical clay tile

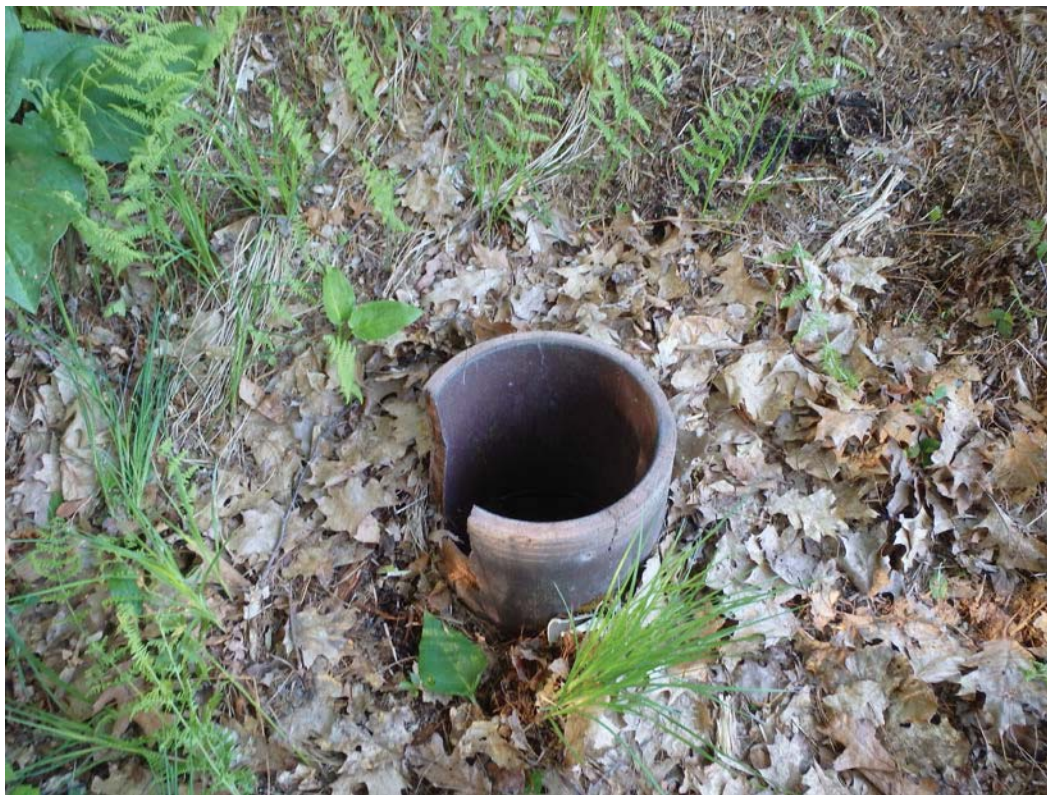
20. View of vertical clay tile

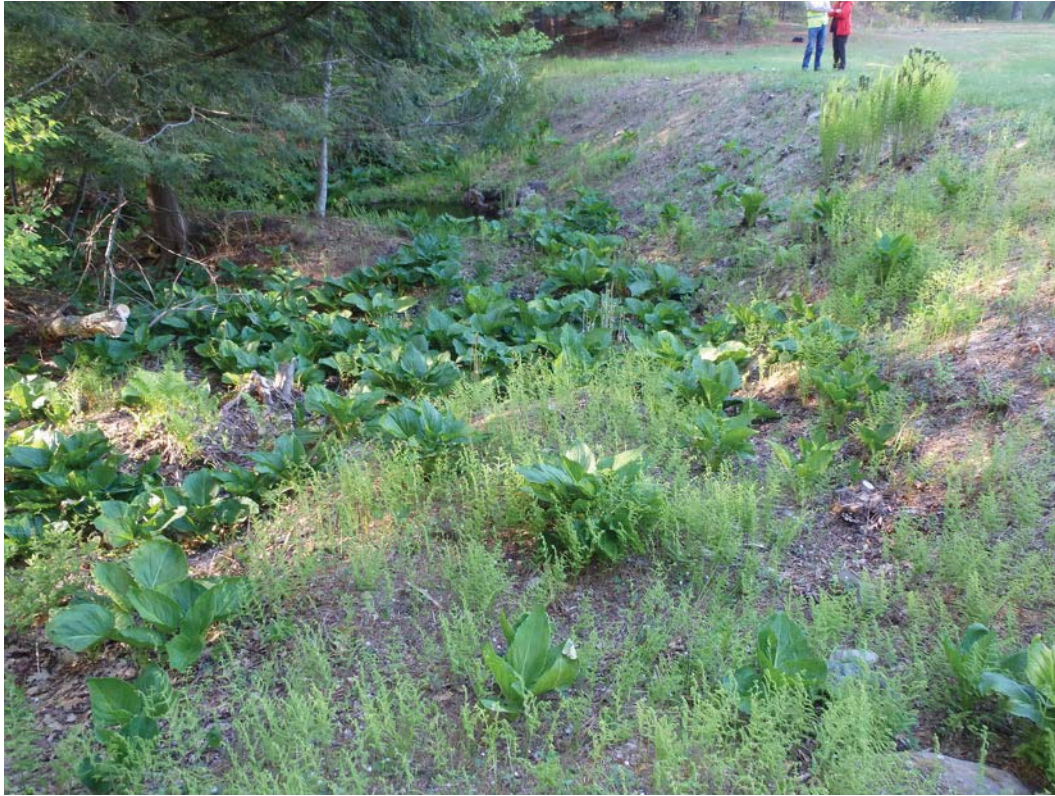
21. Skunk cabbage on lower downstream slope and foundation area indicative of seepage

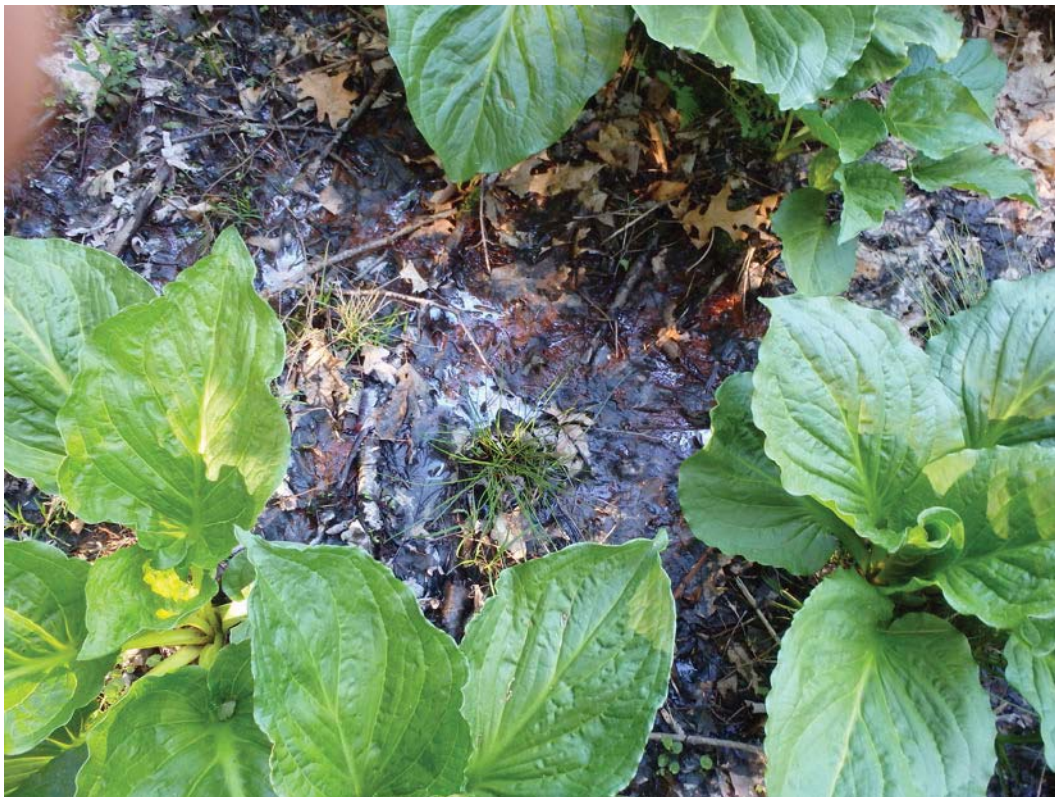
22. Close up of foundation soil surface downstream of embankment showing moisture at surface

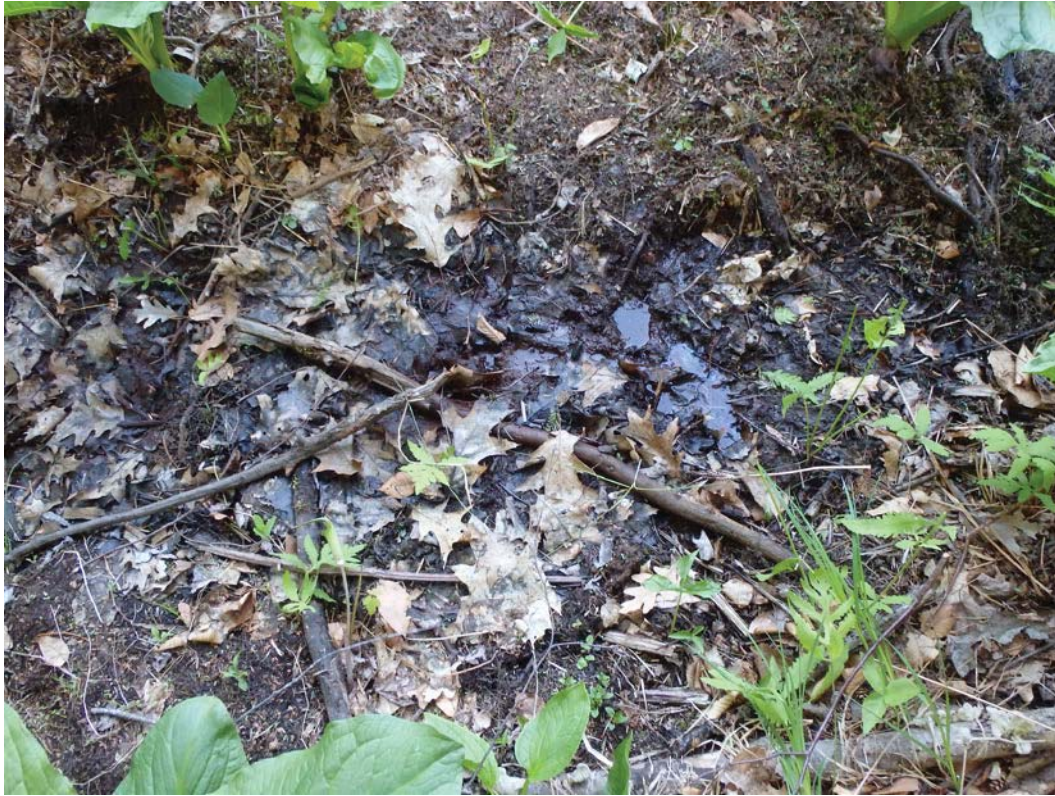
23. Minimal seepage at the embankment toe

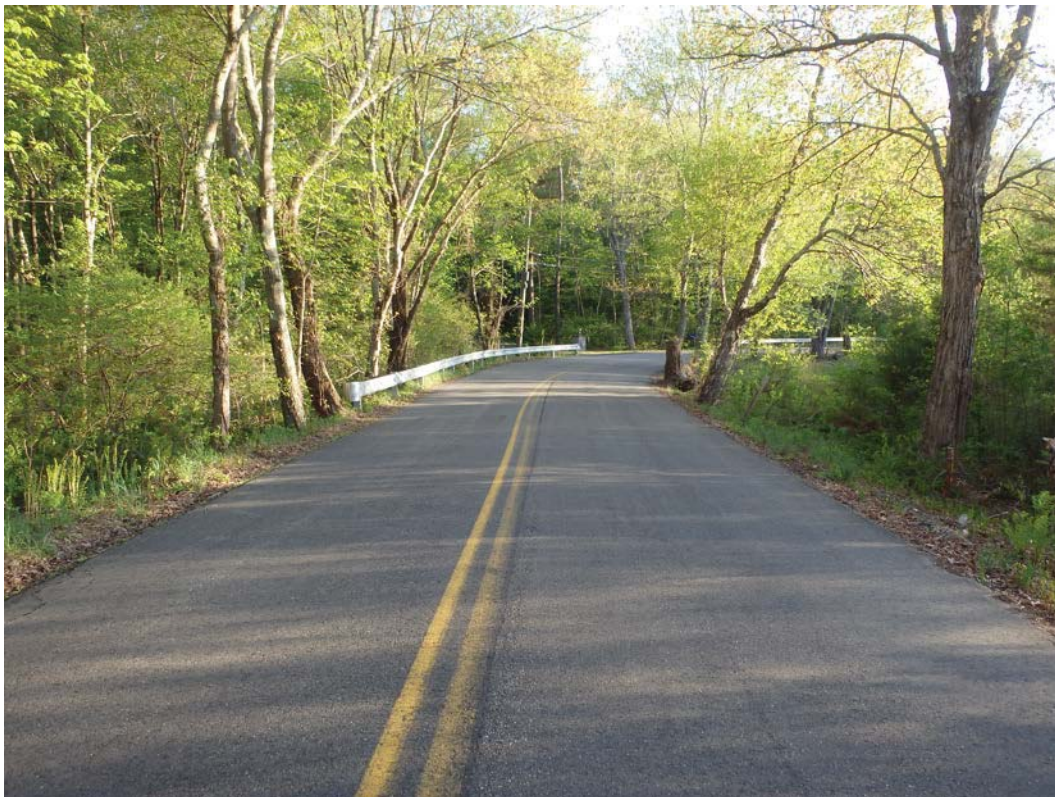
Hunter Road is first downstream crossing. Dam should be no greater than a Class BB Hazard. With more detailed analyses, it might be shown to be a Class A or AA Hazard. See attached screening level Hazard Classification evaluation.

24. First road crossing at Hunter Road

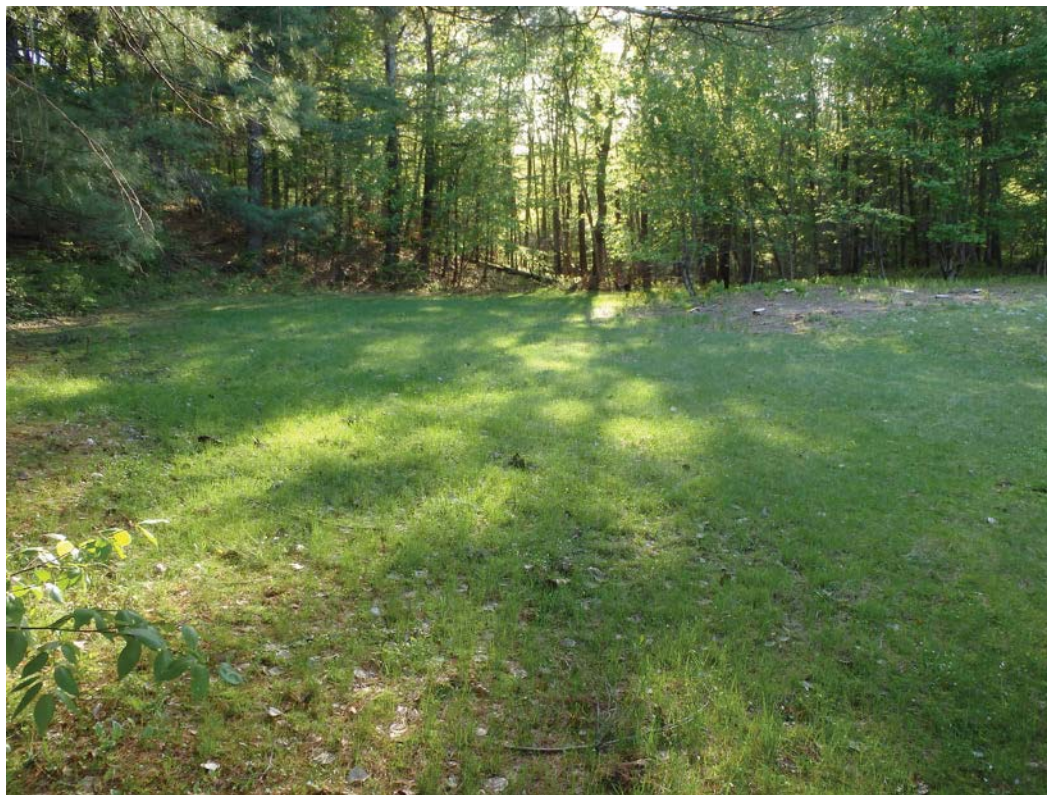
Other: Minimal debris at end of spillway and some saplings and brush crowding outlet end.

27. Some brush and saplings crowding auxiliary spillway outlet channel
