## MEETING AGENDA

### Firehouse Sub-Committee

### 140 Foundation History

November 2, 2023  
Tolland Fire Station 140  
Foundation test Pit  
Observations

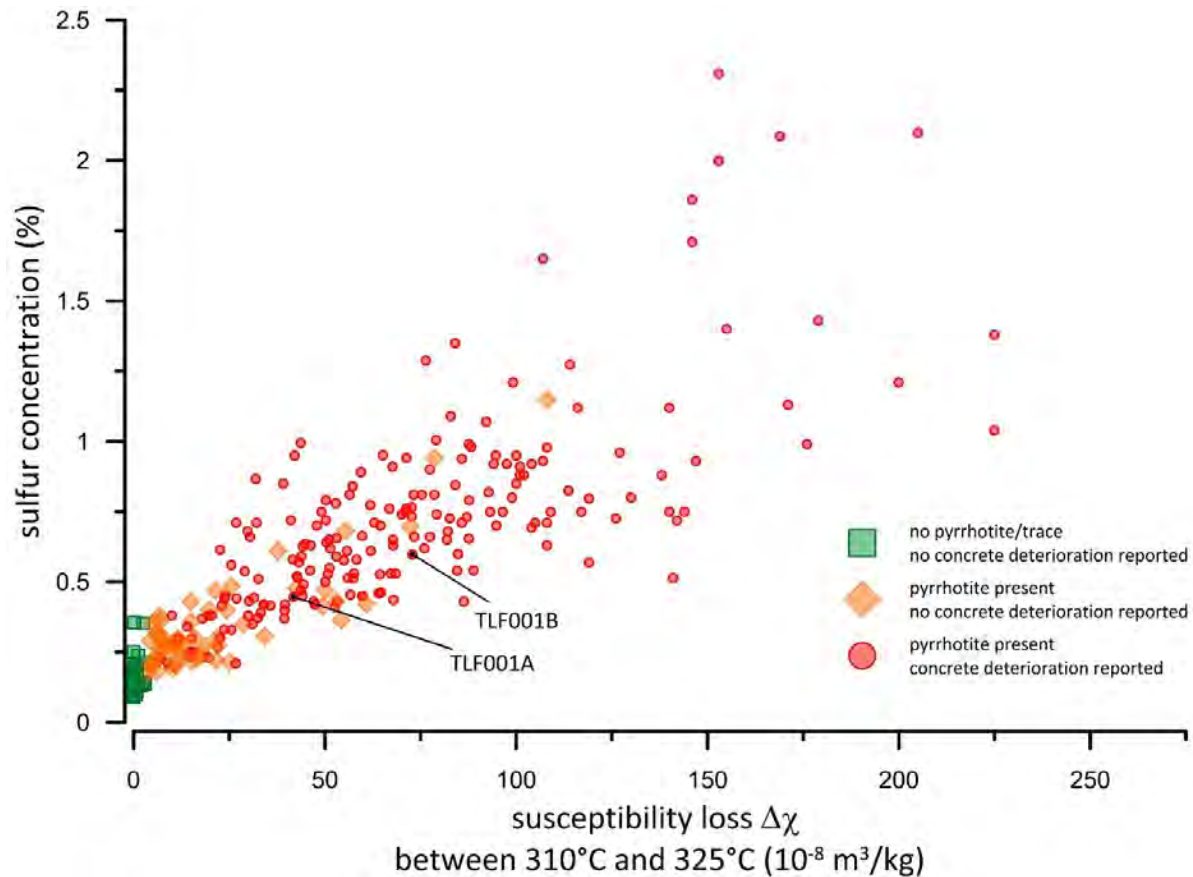
SAMPLE	Loss in Magnetic Susceptibility ( $10^{-8}\text{m}^3/\text{kg}$ )	Average concentration of Sulfur (%)	Estimated Pyrrhotite max concentration (%)
TLF001A (NE wall)	41.8	0.45	1.12
TLF001B (SW wall)	72.9	0.60	1.50

**Pyrrhotite was detected in samples TLF001A and TLF001B.**

Samples were plotted (see reverse side) with similar foundation samples analyzed to date. The graph shows a relationship between the amount of pyrrhotite (as measured via magnetic susceptibility) on the horizontal axis and the concentration of sulfur on the vertical axis. There are other minerals that could contain sulfur in concrete and therefore samples that are clean of

pyrrhotite still may show some minor sulfur concentrations (as seen in the range of sulfur concentrations for samples with no magnetic signal due to pyrrhotite).

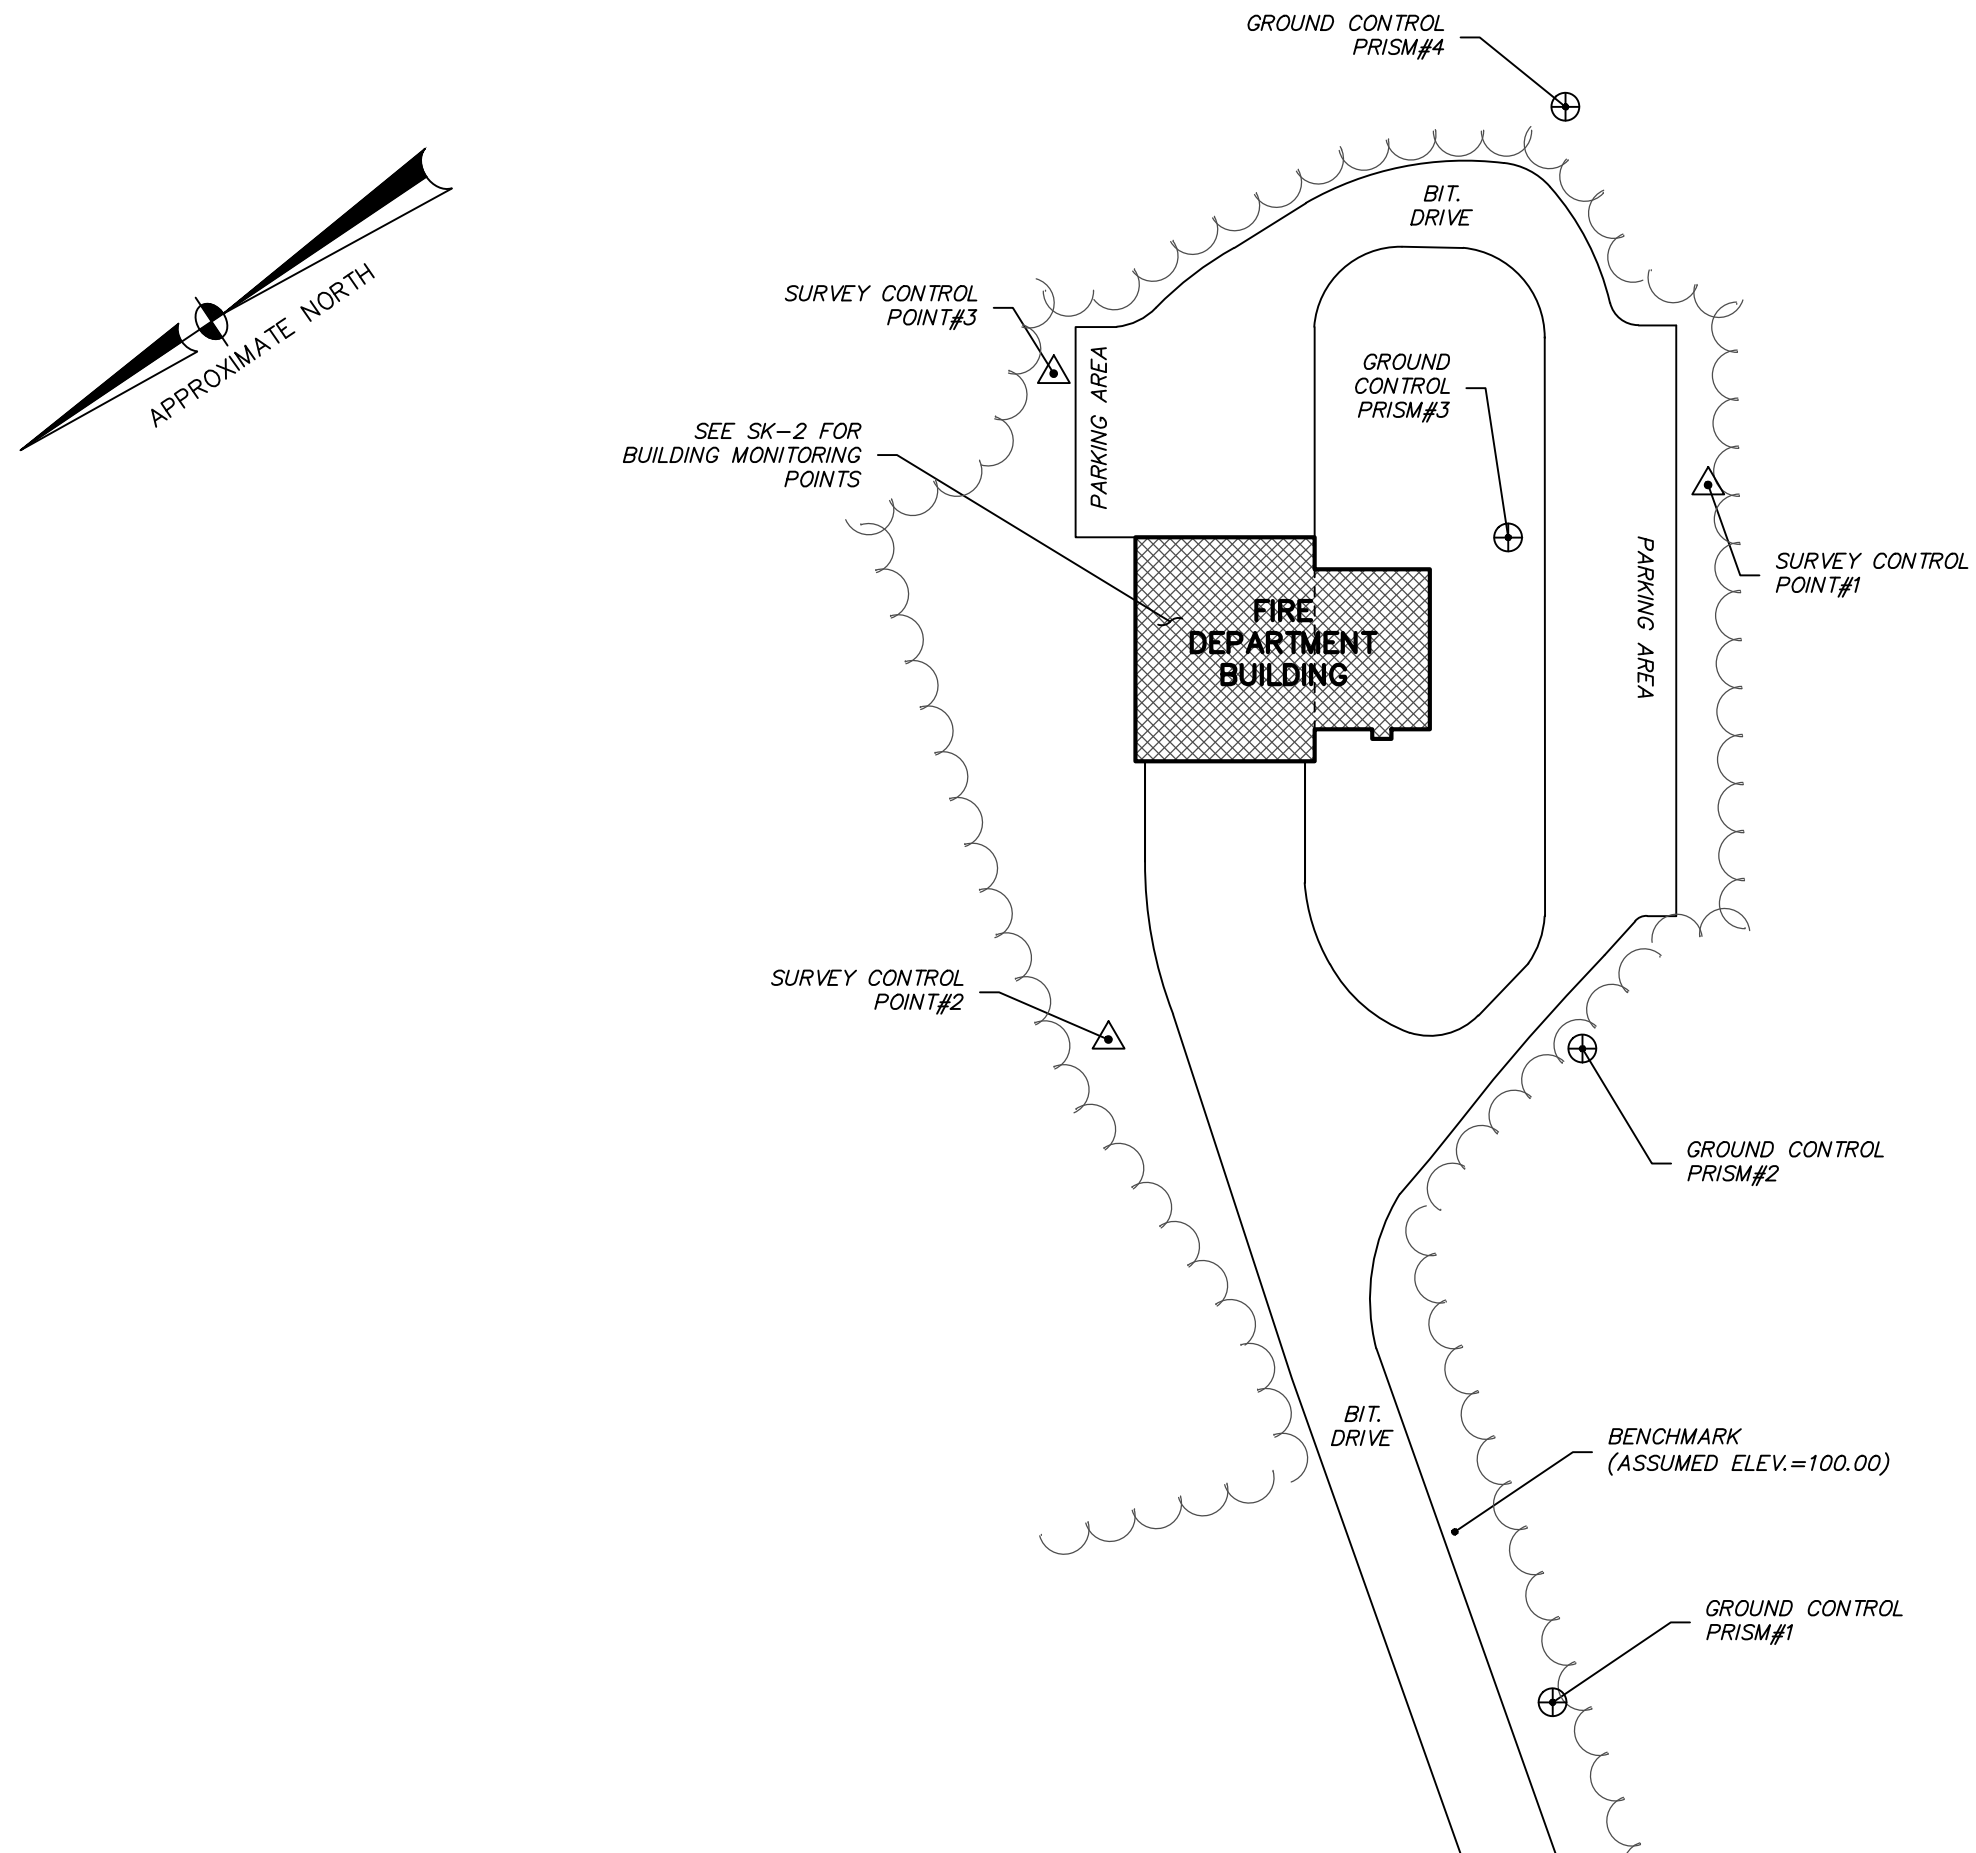
Overall Monitoring Sketch	
Tolland Fire Department Station 140	
64 Crystal Lake Road Tolland, CT

- 8 Robotic Prisms (these are the ones up higher on the block)
- 8 Pins (these are mounted lower on the foundation)
- 3 points on the garage floor

Enclosed please find the survey monitoring information provided by JR Russo. Based on the information provided, no significant movements were detected during that timeframe.

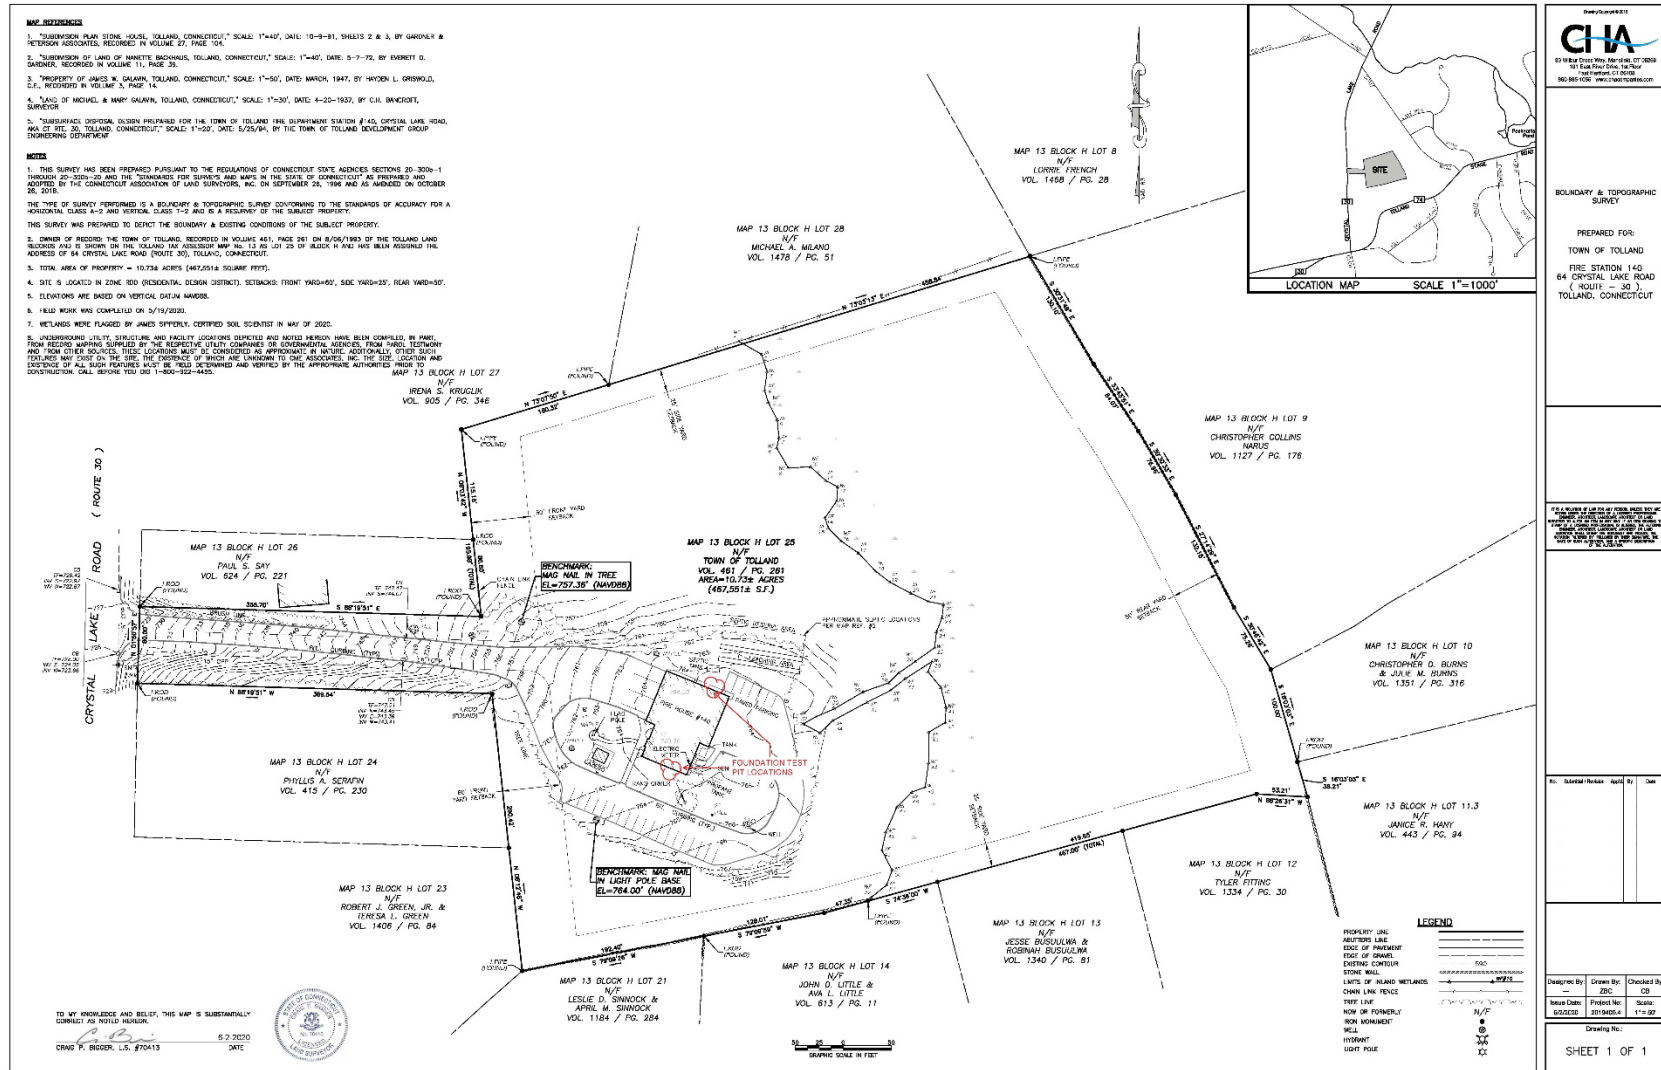
Ryan Cooley and I observed test pits at station 140 this afternoon (2023-11-02).  
 Two test pits were excavated by DPW as shown on the attached plan.

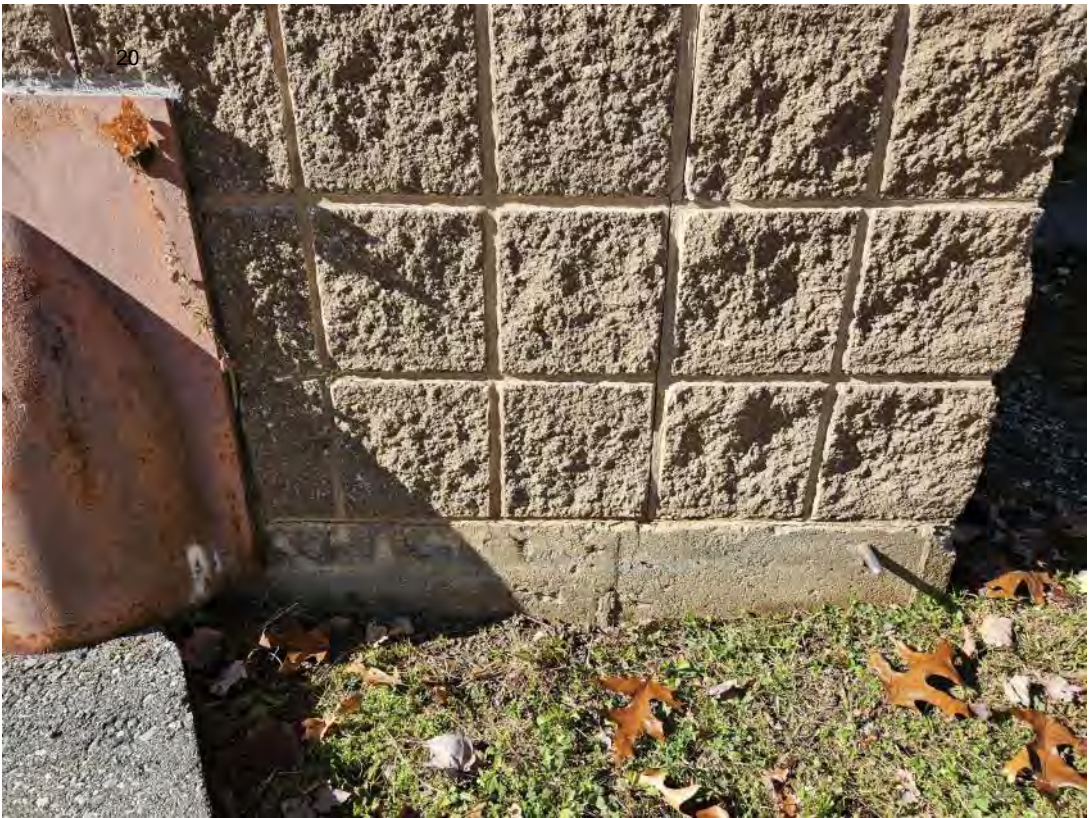
Generally, the building is in good condition with no significant movement or cracking. In the southeast corner of the building, cracking in the foundation did travel up into the CMU in several locations, but it was unsure if it was from foundation settlement or pyrrhotite deterioration.

Southeast Foundation Corner of Vehicle Bay

1. Install a perimeter drain and roof gutter drain around the foundation, as well as damp proof the foundation. This would keep the foundation dry (moisture speeds up the deterioration process) and also allow a full inspection of the foundation when excavation for the perimeter drain installation is performed. This could be a project done before the bay extension to allow the Town to further evaluate the foundation and take preventive measures to hopefully prevent further cracking and deterioration of the concrete from the pyrrhotite.

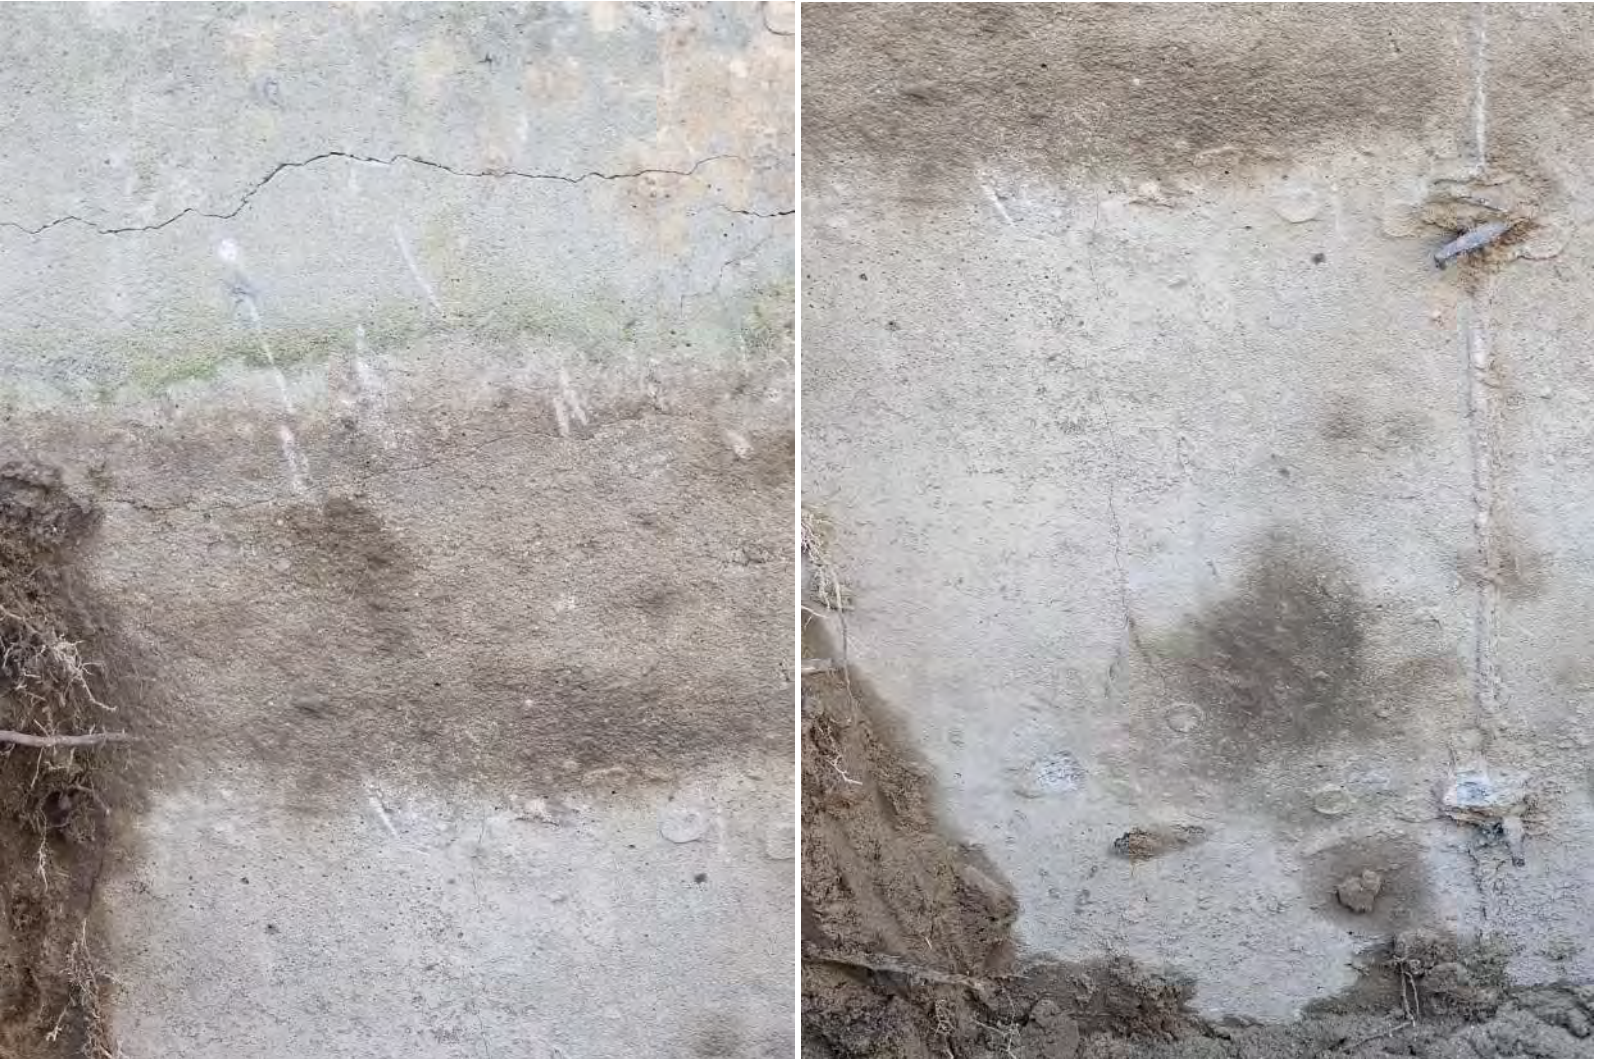
The excavation was as deep as the foundation footing.  
 The test pit on the west side of the building (parking lot side) did not show any cracking.  
 The test pit on the east side had a vertical crack with a few horizontal cracks starting from the vertical one. It is worth noting that this side of the building does show more horizontal cracking at the top of the foundation above grade. This side of the building also appeared wetter than the west side.

Eastern Foundation Wall (Vertical Crack with Horizontal Crack at the Top)
