# Tolland

Old Post Road & Tolland Stage Road (Route 74)

– Road Safety Audit

August 16, 2016

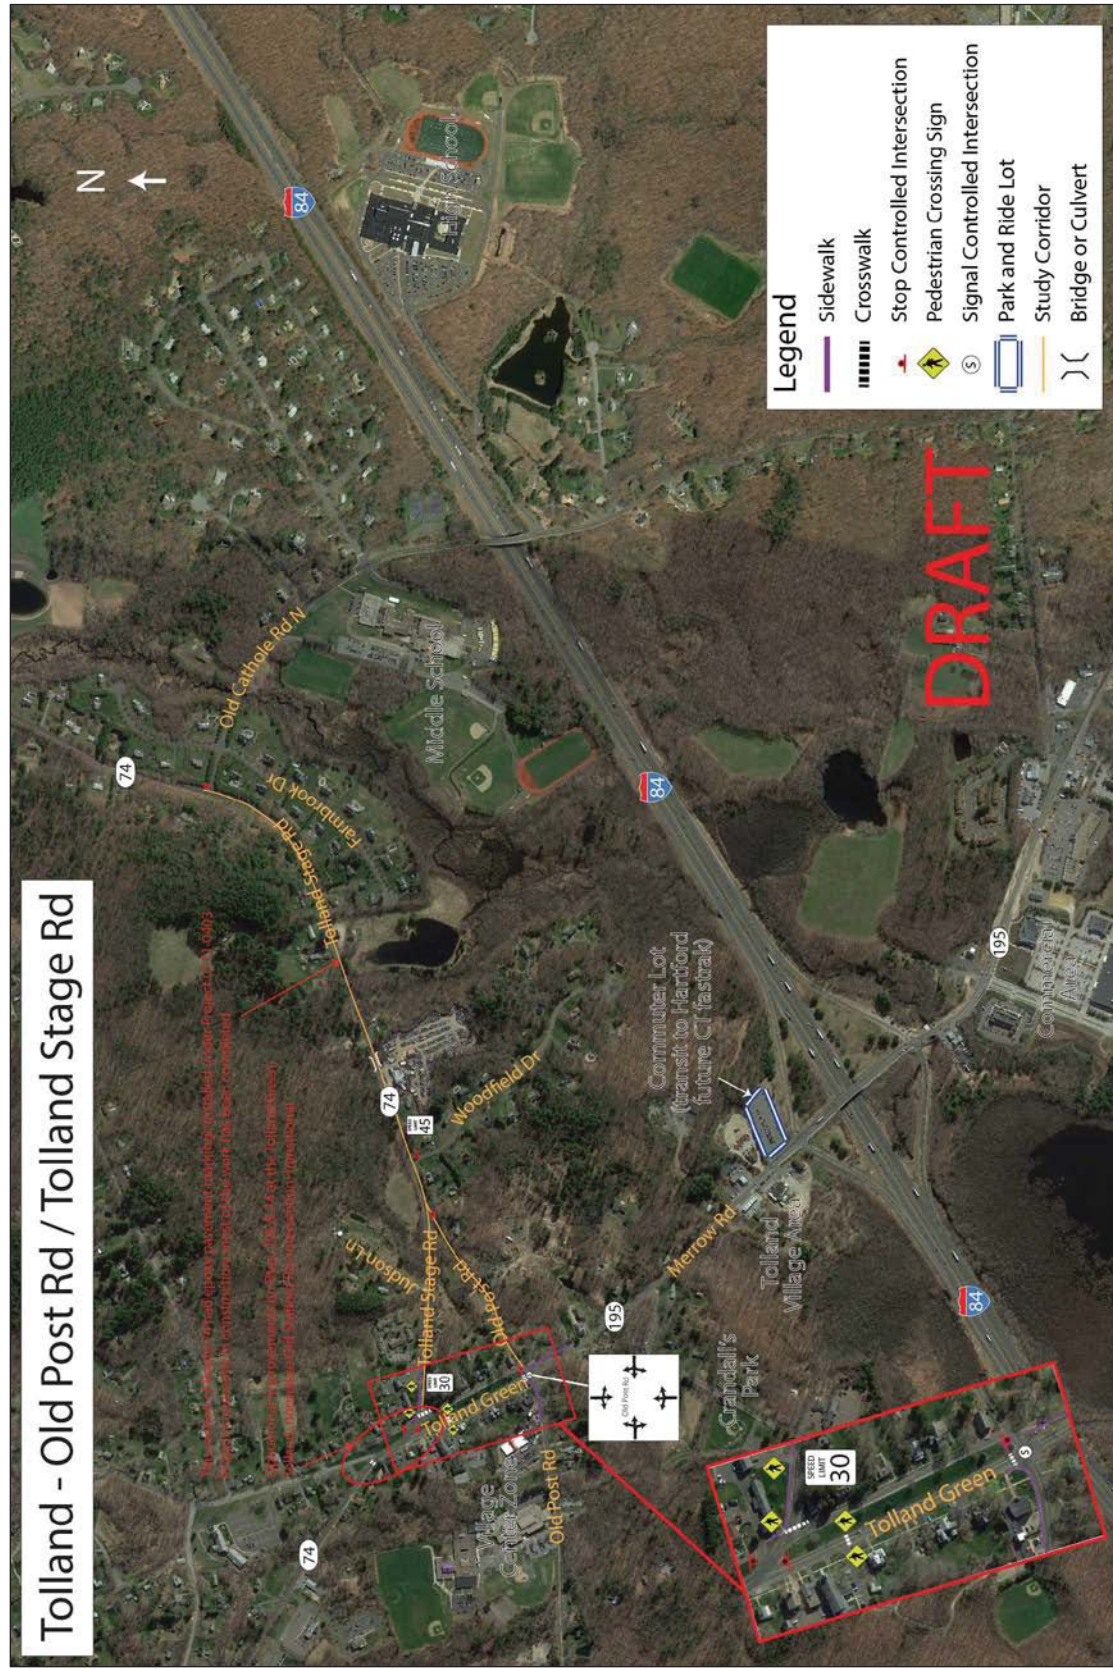
Table 3. Street Inventory

Table 3 is a summary of the roadway conditions throughout the RSA area.

## Tolland - RSA Street Inventory

Road	Width	Sidewalk			Curb	Parking	Shoulder	Ramps	
		Side	Type	Width				Exist	Compliant
Tolland Stage Rd	11'-13'	EB	No	N/A	No	No	N/A	N/A	N/A
(Route 74)	10'-13'	WB	No	N/A	No	No	N/A	N/A	N/A
Old Post Road	11'	EB	No	N/A	Asphalt	No	3'-9'	N/A	N/A
	11'	WB	No	N/A	No	No	5'-13'	Yes	No

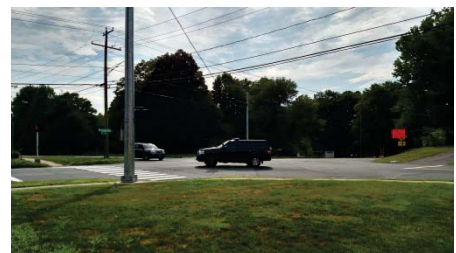
**Figure 5. Intersection of Old Post Road and Tolland Green**

- The signal at the intersection of Old Post Road and Tolland Green has an exclusive pedestrian phase. There is a crosswalk across the northern side of Route 195 and the pedestrian signal heads are countdown. There appears to be insufficient time to cross. The ramps do not have tactile warning strips. (Figure 5).
- Old Post Road has no shoulders and has 10 foot wide lanes at the western end and 13 foot wide lanes at the eastern end. The side slopes are steep and the road is curvy and has a steep grade. Any widening would require retaining walls. (Figure 6).
- It is difficult to see the signal when approaching from Old Post Road.
- The utility poles on Old Post Road are on the westbound side, there is an old farm rock wall on the eastbound side.
- There is an old catch basin just off the roadway that has sunken in and has been partially filled in (Figure 7).

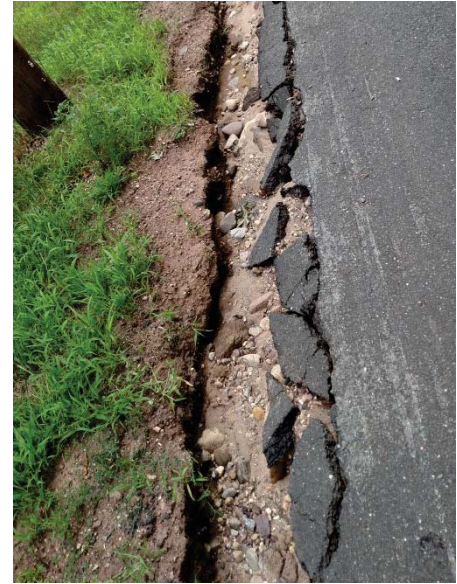
**Figure 8. Rutting on Old Post Road**

- There is a mixture of bicycle friendly and non-friendly catch basin grates.
- There is a driveway curb cut and vacant lot on Old Post Road.
- The eastern end of Old Post Road has severe rutting, and the pavement has begun to break up (Figure 8).

- There is rutting on Old Post Road due to drainage issues.
- Several of the catch basins on Old Post Road are filled. This may be contributing to the drainage issues but it is unclear if they are active catch basins or should be converted to manholes.

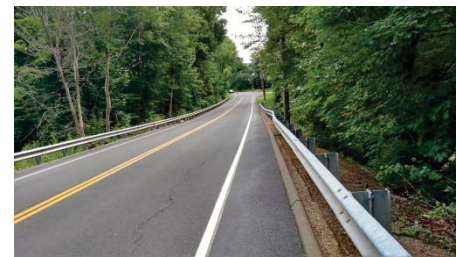
**Figure 9. Wide Shoulders on Route 74**

- There is no posted speed limit on Old Post Road.
- Route 74 (Tolland Stage Road) pavement is in good condition and has centerline rumble strips. The shoulders are five feet wide on both sides with 11 foot wide lanes (Figure 9). Towards Old Cathole Road the road begins to widen and the shoulders increase to between 9 and 13 feet wide. The lane striping paint is reflective epoxy paint.

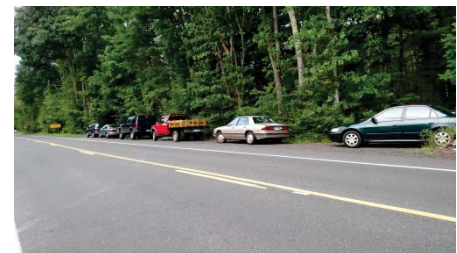
**Figure 10. Cars Parked in the Shoulder**

- The utilities on Route 74 are on the eastbound side until Bill's Auto where they transition to the westbound side.
- There are several passing zones along the corridor on Route 74. One of the passing zones, in front of Bill's Auto, creates a pinch point due to vehicles parking in the shoulder on the opposite side of the road and a culvert crossing with guide rail (Figure 10).

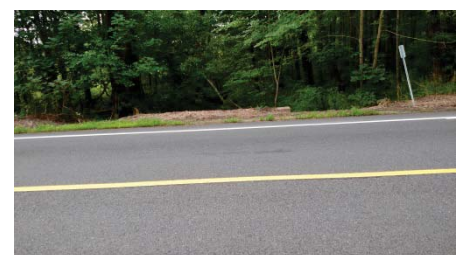
**Figure 11. Culvert Without Protection**

- Heading eastbound the speed limit is 45 mph.
- There are two culvert crossings on Route 74 that do not have guide rail. One crossing is where the utilities transition from the north to the south side of the road, the other is approximately 300 feet east. (Figure 11).

- There are several culverts within the clear zone on the Route 74 but most do not have guide rails.
- The town would like to see sidewalks along Route 74 so that students can safely walk from the schools to the library.

1. Widen Old Post Road by one to two feet to improve sight distances and add a shoulder.
2. Install guard rails at the culverts on Tolland Stage Road (Figure 23).

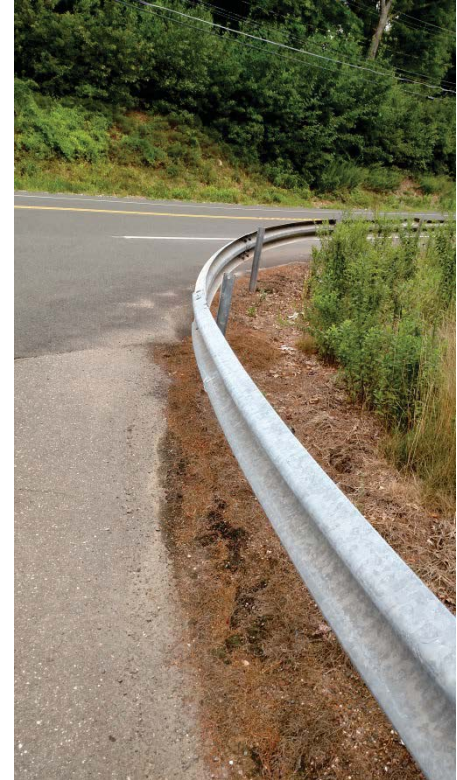
Figure 12. Loose Guard Rail

- Intersections are lighted but there is no street lighting elsewhere.
- The stop sign at Old Cathole Road is set back (approximately 30 feet) from the intersection.
- The guard rail on the northeast corner of the Route 74 and Old Cathole Road intersection is loose (Figure 12).
- There is no sidewalk on Old Cathole Road. A sidewalk would best be situated on the southbound side.
- Old Cathole Road is need of repaving (Figure 13).

8. Fix the broken guide rail at the Old Cathole Road and Route 74 intersection (Figure 19).
9. Evaluate the stop bar location on Old Cathole Road (Figure 20).
10. Town to coordinate with CTDOT to conduct a lighting study/evaluation along the corridor.
11. Use active speed detection signs along Route 74 to assist in decreasing speeds.
12. Upgrade pedestrian crossing signs to be retroreflective.
13. Relocate pedestrian crossing signs for the crosswalk at Route 74 and Tolland Green to be in the correct locations by the crosswalk (Figure 21).
14. Retime the pedestrian signal phase for the Route 74 and Old Post Road intersection to meet current standards.
15. Install bike racks at key destination.

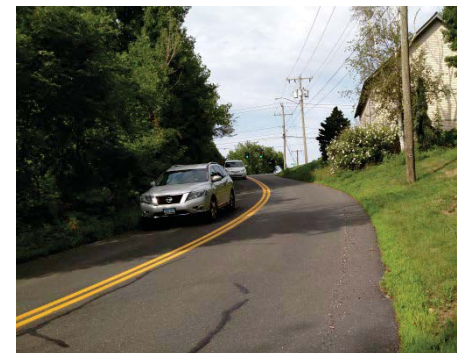
Figure 14. Narrow Curvy Road (Old Post Road)

- Tolland is a rural community and is very concerned about keeping its rural character and view sheds. The town has submitted a proposal to the state to designate segments of Route 74 (Tolland Stage Road) as a scenic road.
- Old Post Road is a town owned curvy narrow road, and has no shoulder. There is poor sight distance at the curves. It is difficult to see vehicles coming around the curve, especially with the location of a stone wall.
- There are no sidewalks on Old Post Road.
- There are no speed limit signs on Old Post Road.
- There is no room to put a sidewalk in on Old Post Road without widening the cross-section or converting the road to one-way traffic. The narrow and steep side slopes would require a retaining wall if widened. It could also require right-of-way acquisitions and this could be a challenge with the Arts Building on the corner of

Old Post Road and Route 195, which is close to the road with steep side grades. (Figure 14).

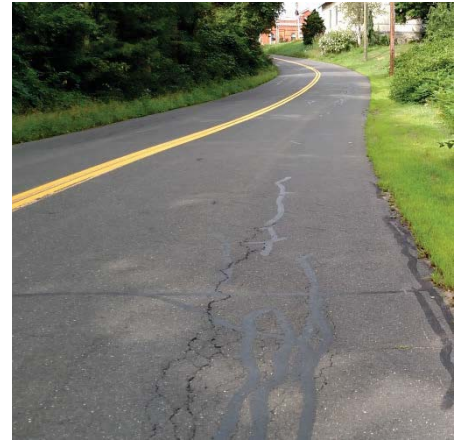
**Figure 15. Deteriorating Condition of Old Post Road**

- Old Post Road is beginning to crack (Figure 15).
- Where Old Post Road intersects Route 74, there is poor sight distance. Vehicles traveling west on Route 74 turning onto Old Post Road often take the turn at high speed due to the roadway geometry.

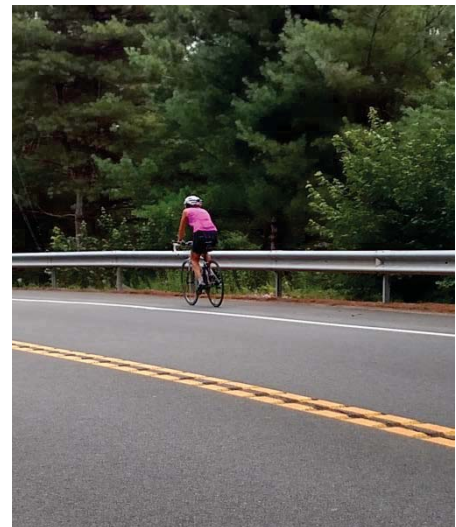
**Figure 16. Cyclist in Shoulder on Route 74**

- Route 74 was recently paved and there are 5 foot shoulders. The wide shoulders provide a place for pedestrians to run and walk and for cyclists (Figure 16).

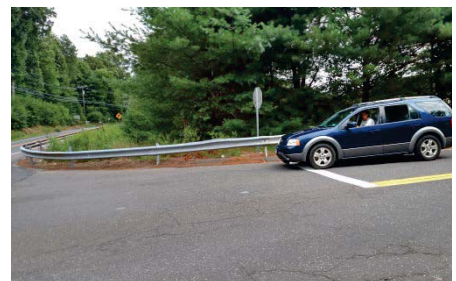
**Figure 17. Stop Bar At Old Cathole Road Set Back Far**

- The sight distances at the Old Cathole Road intersection with Route 74 appear to be adequate.
- The stop bar and stop sign on Old Cathole Road are set back far from the intersection with Route 74. This has caused some difficulty with the turning radius of the school buses. (Figure 17).
